Manhole Inspection Summary

Manhole # S15II_004MH

Insp Date: **10/29/07 2:47 PM**

Location Address: **REAR 2541 NORTH AVE**

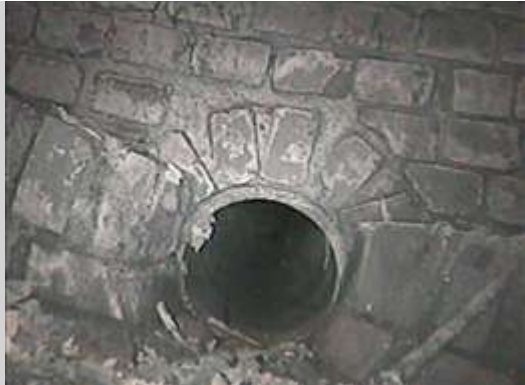
12 O'Clock Outflow

8 in. Circular Gravity Sewer
Pipe Out @ 12 O'Clock

Pipe Height: (in.) Direct
Pipe Material: **Clay** ☐ Pipe Lined
Invert Depth: **8.65** (ft.) Flow Characteristics: **Slow**
Deposits: ☒ None ☐ Mud ☐ Sludge ☐ Debris ☐ Grease
Silt Depth: (in.) Deposits Extent:
Infiltration: **None** Pipe Seal Cond: **Sound**

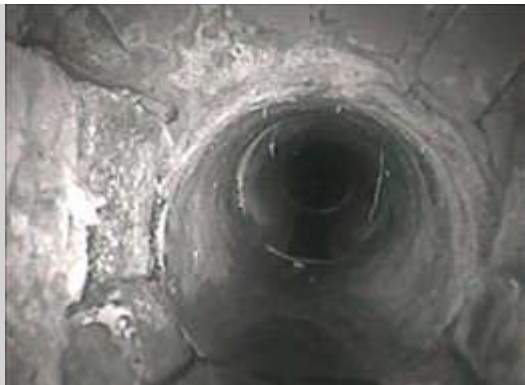
3 O'Clock Inflow

8 in. Circular Gravity Sewer
Pipe In @ 3 O'Clock

Pipe Height: (in.) Direct
Pipe Material: **Clay** ☐ Pipe Lined
Invert Depth: **8.63** (ft.) Flow Characteristics: **None**
Deposits: ☒ None ☐ Mud ☐ Sludge ☐ Debris ☐ Grease
Silt Depth: (in.) Deposits Extent:
Infiltration: **None** Pipe Seal Cond: **Sound**

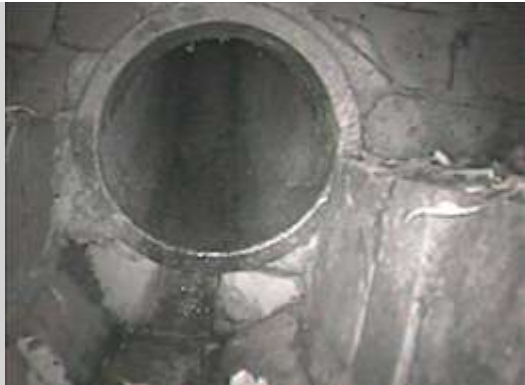
6 O'Clock Inflow

6 in. Circular Gravity Sewer

Pipe In @ 6 O'Clock

Invert Depth: **8.18** (ft.) Flow Characteristics: **None**

Infiltration: **None**

Pipe Seal Cond: **Sound**

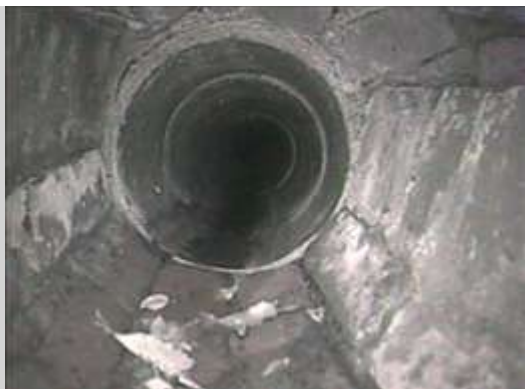
9 O'Clock Inflow

8 in. Circular Gravity Sewer

Pipe In @ 9 O'Clock

Invert Depth: **8.28** (ft.) Flow Characteristics: **Slow**

Infiltration: **None**

Pipe Seal Cond: **Sound**
